Rapid Inventory of Earthquake Damage (RIED)

The 25 January 1999 Quindío earthquake in Colombia was a major disaster for the coffee-growing region in Colombia. Most of the damage occurred in the city of Armenia and surrounding villages. Damage due to earthquakes is strongly related to topographic and subsurface geotechnical conditions underneath structures and houses. The RIED project used aerial photographs to obtain a rapid inventory of the earthquake damage right after the seismic event. This inventory was subsequently used to identify any existing relation with subsurface- and topographic conditions.

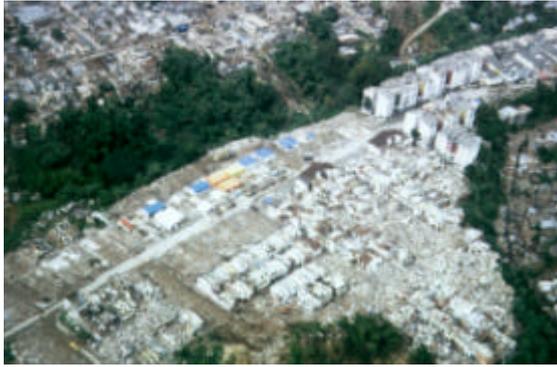
Photo 1. Neighborhood in the city of Armenia that was almost completely destroyed by the earthquake

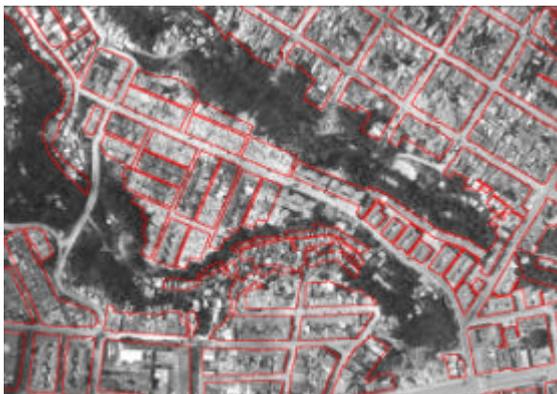
Figure 2. Digital orthophoto combined with existing cadastral data in the GIS

The aerial photographs were ortho-corrected (removal of camera- and topographic distortion) and with existing cadastral and topographic information a comprehensive Geographic Information System (GIS) database was set up in a short amount of time. The aerial photographs were interpreted in order to assess for each individual house or building whether it was damaged and what type of damage

was inflicted (see Figure 2). The damaged structures have been classified and marked on aerial photographs and simultaneously imported in a GIS. Maps for various types of damage to structures have been made and analyzed. In this way a large database was constructed with in total more than 33000 observations. An example of an analysis carried out on the basis of this damage inventory is given in Figure 3.

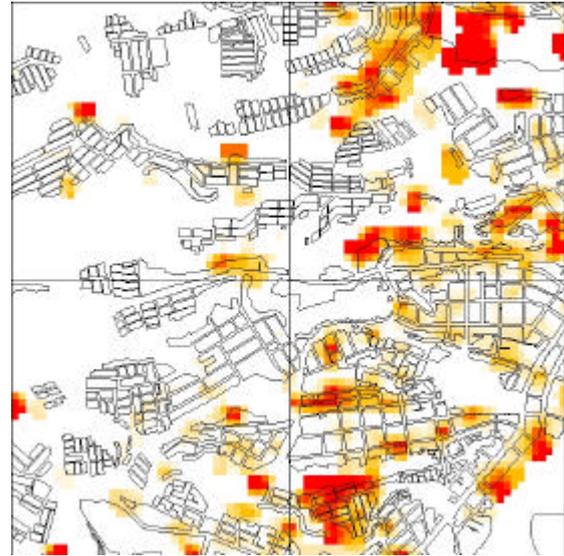
Figure 3. Damage intensity (damaged buildings as percentage of the total number of buildings)

The damage inventory made by aerial photographs clearly shows that the damage is concentrated in a more or less wedge-shaped area bounded by the Armenia fault on the East side and by alignments in the topography on the West side. The coincidence of this alignment with the boundary of the most damaged areas may indicate that the alignment in the topography is in fact a fault trace. The damage inventory shows further that topographical effects are of important influence on the damage inflicted on the surface structures. The apriory assumed influence of the landfills on the damage of structures is less obvious from the inventory by

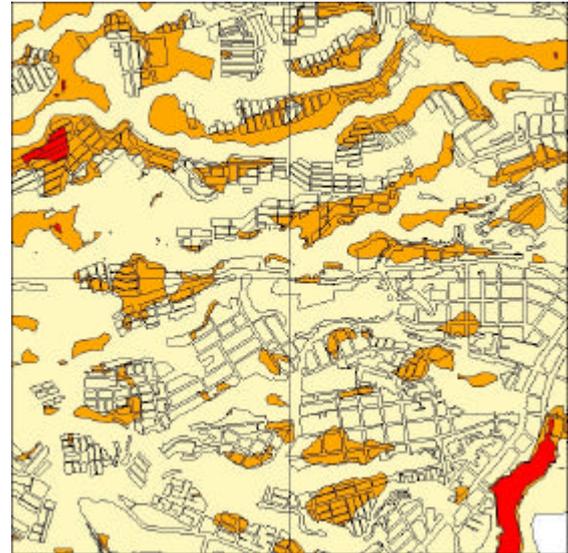
Figure 5. Potential areas where the topographic resonance effect may take place

Additional measures should be taken to reinforce the constructions in those areas, or to avoid building structures in such areas. The aerial photographs also show that three-dimensional site effects occur on some of the ridges in the topography. As there is very little known of these effects a research study has been initiated to study in more detail the three-dimensional aspects of topographic effects on seismic response.
