# “De Stenen Man”: strong guardian or weak link?

## ABSTRACT

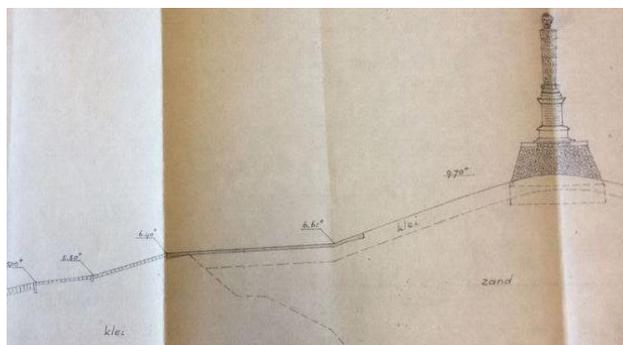
Figure 4 shows the side view of the dike. ‘De Stenen Man’ is placed on the crest of the *Westerzeedijk*. It shows that the statue is placed on a pedestal that is supported by a shallow foundation. Further, it shows on which side the old clay dike is located, and how the dike has been heightened. Figure 5 shows a side view of the pedestal and a shallow foundation. The pedestal is filled with rubble as well as with mud and sand. Figure 5 shows that the bottom of the foundation is

Figure 4 Side view of the Stenen Man on the dike. The old clay dike is visible to the left. Source: photo the original sketch (1968-1971, *Tresoar* inventory number 485)

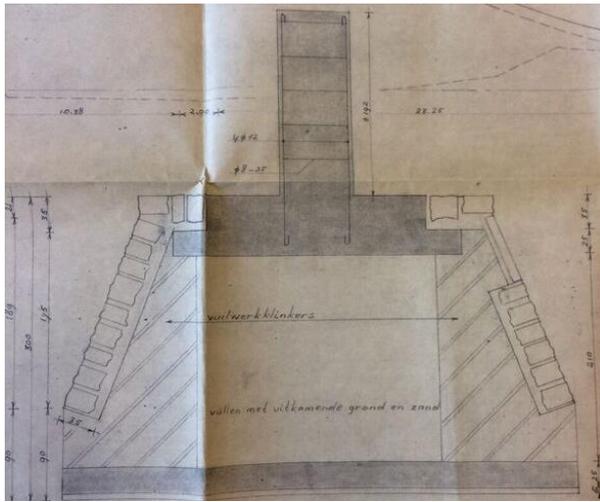
Figure 5 Side view of pedestal and shallow foundation. Source: photo the original sketch (1968-1971, Tresoor inventory number 485)

located at 1.50 m below the ground level at the crest. The ground level is 9.54 m +NAP, so the foundation is located at 8.04 m +NAP.

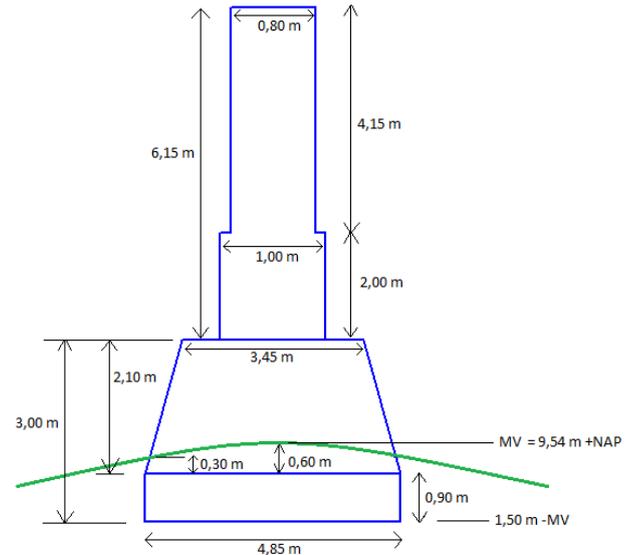
The accuracy of the magnetometric probe and the seismic probe are both 0.25 m, so the range of the measured depth is 0.50 m for both methods. Table 1 shows that the difference between the measured depth between both methods is exactly 0.25 m, which means that, taking the accuracy into account, the actual depth of the bottom of the foundation must be within -1.65 m +MV and -1.40 m +MV. The technical drawing from the archive research shows a depth of -1.50 m +MV and is therefore in accordance with the soil survey. For the safety assessment, it is therefore confirmed that the bottom of the foundation is located at a depth of 8.04 m +NAP. Based on this information, 'De Stenen Man' and its foundation have been schematized (see Figure 6).

Figure 6 Schematization of 'De Stenen Man'. NAP: mean sea level, MV: ground level at the crest of the dike

Stenen Man'. Therefore, the dike section is assessed as unsafe for inward macrostability. Further, it shows a tenfold increase of the probability of failure due to the inclusion of NWO 'De Stenen Man'.

The results show that the probability of failure increases due to the extra loads by 'De Stenen Man' for inward as well for outward macrostability. The impact of the statue to the probability of failure is significant for both failure mechanisms, so it is recommended to consider this impact in future safety assessment.
