Cracking and delamination of metal organic vapour deposited alumina and silica films

V. A. C. Haanappel, H. D. van Corbach, T. Fransen* and P. J. Gellings

Department of Chemical Technology, University of Twente, P.O. Box 217, Enschede (Netherlands)

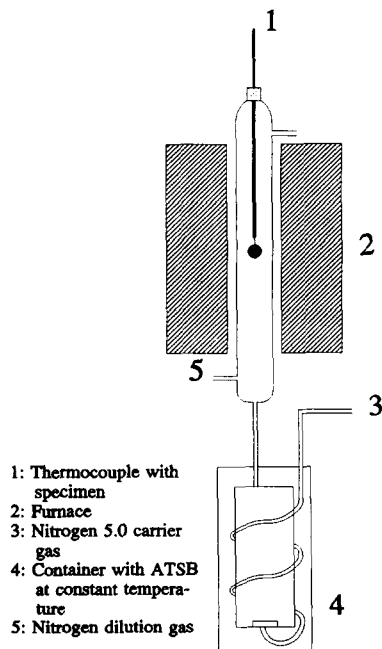
A schematic view of the experimental apparatus is shown in Fig. 1. The vapours were transported to the vertical furnace (with a quartz tube) by bubbling nitrogen through the precursor, heated by silicon oil. This gas stream was subsequently mixed with a diluent gas flow of nitrogen to obtain the desired gas-phase concentration. The specimens were attached to a ceramic tube with a thermocouple on the inside in order to measure the substrate temperature and control the furnace temperature.

Fig. 1. Schematic view of the MOCVD equipment.

Thin silica films were produced by the decomposition of di-acetoxy-di-tertiary-butoxide-silane (DADBS) on AISI 304 and Incoloy 800H. The deposition set-up (see Fig. 1) was the same as that for alumina. The deposition parameters used for a film growth of $0.75 \text{ mg cm}^{-2} \text{ h}^{-1}$ ($3 \text{ } \mu\text{m h}^{-1}$) were: silicon oil bath with DADBS, $80 \text{ }^\circ\text{C}$; carrier gas flow (N_2), 400 ml min^{-1} (STP); diluent gas flow (N_2), 400 ml min^{-1} (STP); substrate temperature, $560 \text{ }^\circ\text{C}$.

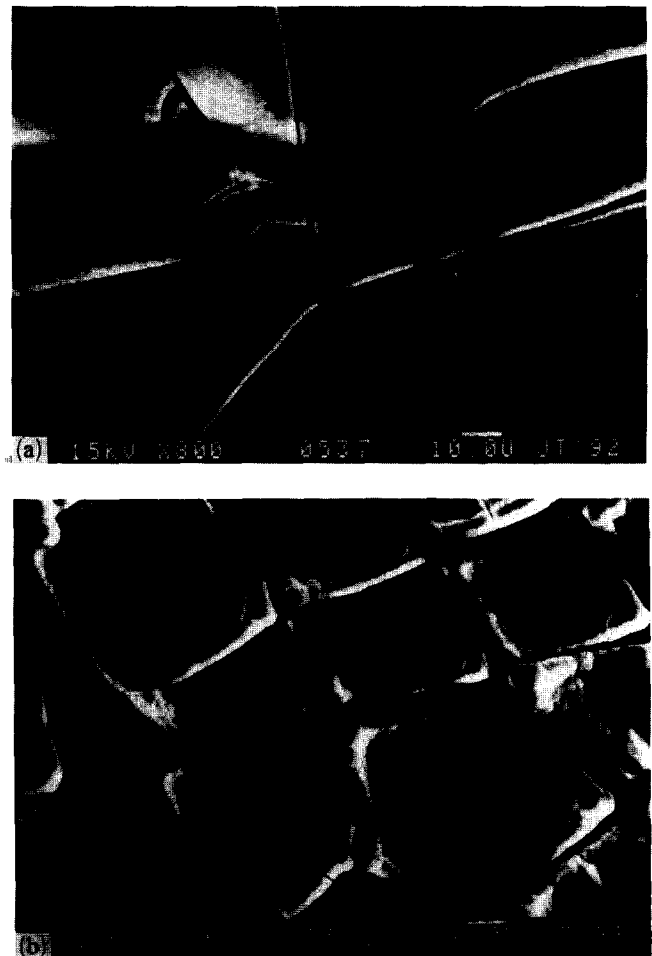
delamination of the films occurring during the deposition was confirmed by observations with SEM and EDX. Figures 2(a) and 2(b) show the delamination of the alumina film after deposition times of 45 min and 60 min respectively (film growth $2 \text{ } \mu\text{m h}^{-1}$). These observations clearly show that cracking and delamination take place during the deposition process, because deposition on the cracked edges and corners is more pronounced, as shown by the round corners after longer deposition times. The same phenomena were observed with SiO_2 coatings. Figures 3(a) and 3(b) show the delaminated silica film deposited for 35 min and 70 min respectively (film growth: $3 \text{ } \mu\text{m h}^{-1}$). Beneath the curled and spalled alumina film, new alumina was detected. This was more pronounced after longer deposition times. At the sites where delamination of the film was initiated, almost no alumina could be detected, indicating delamination after interfacial cracking. For a coating thickness less than the critical thickness, only cracking of the alumina film (thickness $0.8 \text{ } \mu\text{m}$) was observed (Fig. 4). At this stage no decohesion could be found.

Fig. 2. Delaminated Al_2O_3 film on AISI 304: deposition time (a) 45 min, (b) 60 min.

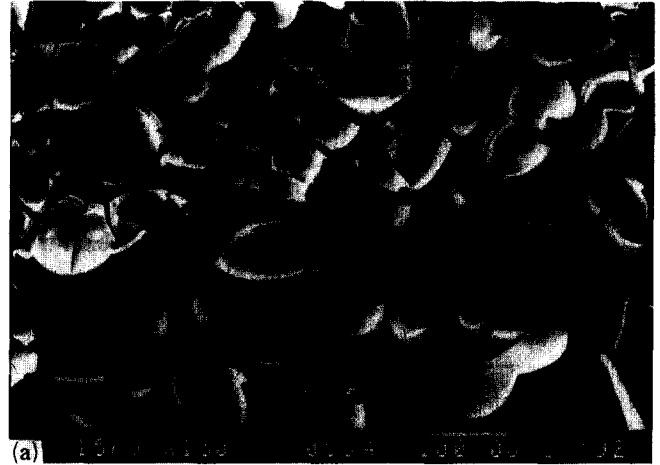
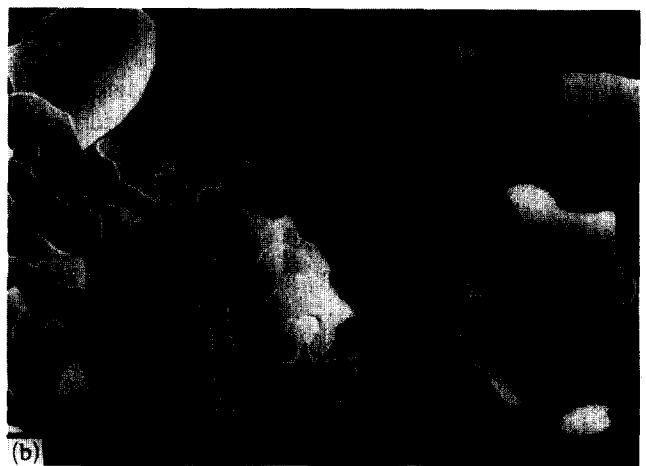
Fig. 5. (a) Delaminated Al₂O₃ film on AISI 304 (deposition time 60 min); (b) delaminated SiO₂ film on AISI 304 (deposition time 35 min).

Figures 5(a) and 5(b) show spallation and delamination of alumina and silica films. Spallation during the deposition process was confirmed by a discontinuous increase of the deposition rate, expressed as milligrams

considered to be the factors dominating the fracture mechanism. Furthermore, it was observed that for alumina on AISI 304 crack formation preceded delamination (see Figs. 4 and 5(a)). It is therefore assumed that in these cases film cracking and film decohesion are not simultaneous processes, thus $\Gamma_{\text{film}}/\Gamma_{\text{interface}} < 4$.

At known values of E_f , s and R are known (see Table 1) and the stress parallel to the interface can be calculated. This means that the maximum stress at the outside of the film and at the substrate–film interface, in this case for $s = (\text{coating thickness})/2$, can be determined. The total internal stress can be calculated from eqn. (2). With typical values of $s = 0.5 \mu\text{m}$ and $R = 50 \mu\text{m}$ (see Fig. 5(a)), the internal stress for Al_2O_3 –AISI 304 is $\sim 3.8 \times 10^9 \text{ N m}^{-2}$.

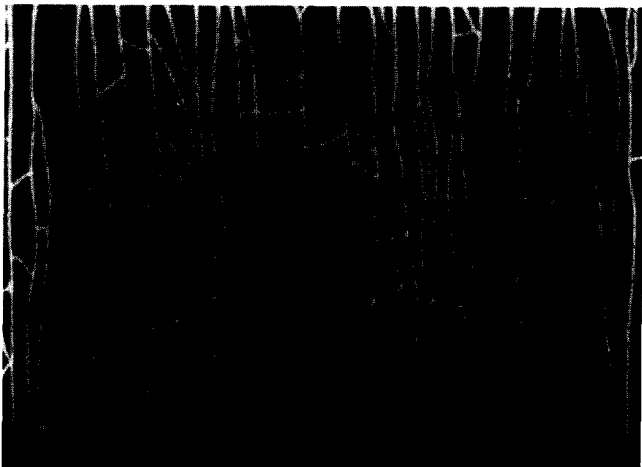
Fig. 4. SEM image showing cracks of a 0.8 μm Al₂O₃ film on AISI 304.

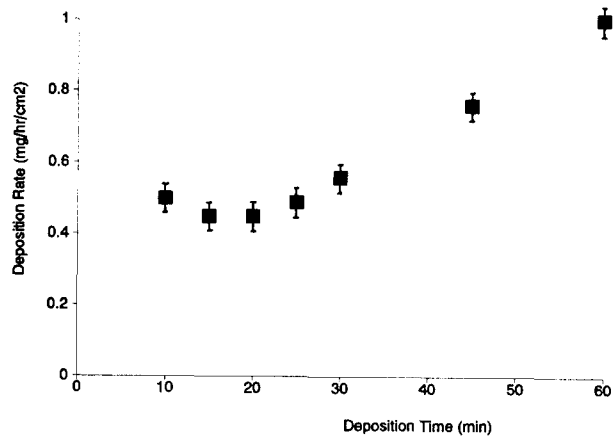
Fig. 6. Deposition rate of Al₂O₃ (milligrams per hour per unit substrate surface) as a function of the deposition time (layer thickness was determined by weighing the sample before and after the deposition process).

per hour per unit substrate surface (see Fig. 6). This can be explained by an increased surface area after cracking and delamination (curling away of the film from the substrate).

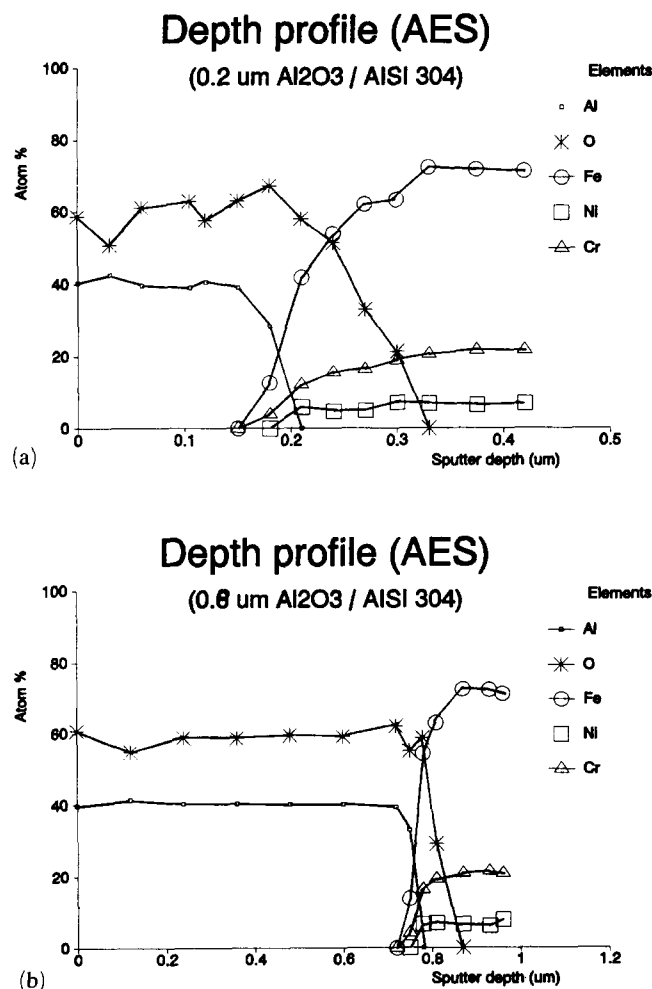
Auger depth profiles were obtained for samples deposited with alumina at 330 °C (thickness 0.2 and 0.8 μm). The profiles are shown in Figs. 7(a) and 7(b). No carbon or other contaminants could be detected in the oxide layer, either in the coating or at the interface.

Fig. 7. AES depth profile of the Al₂O₃ film on AISI 304: film thickness (a) 0.2 μm , (b) 0.8 μm .

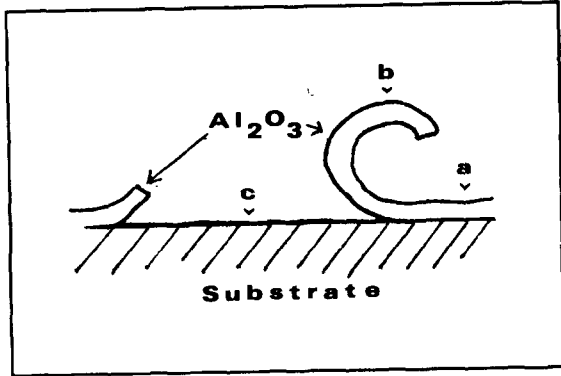
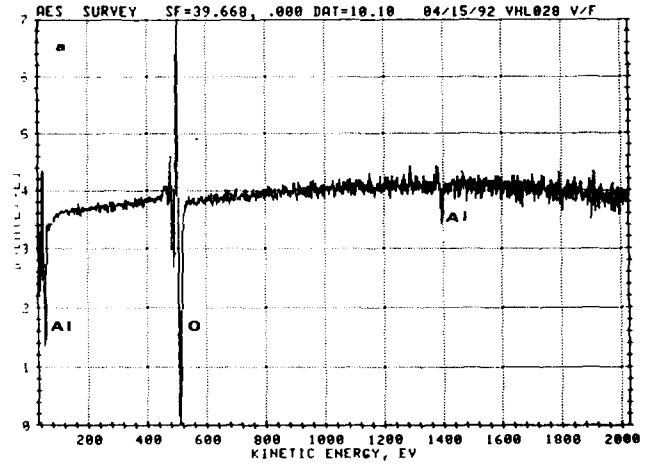
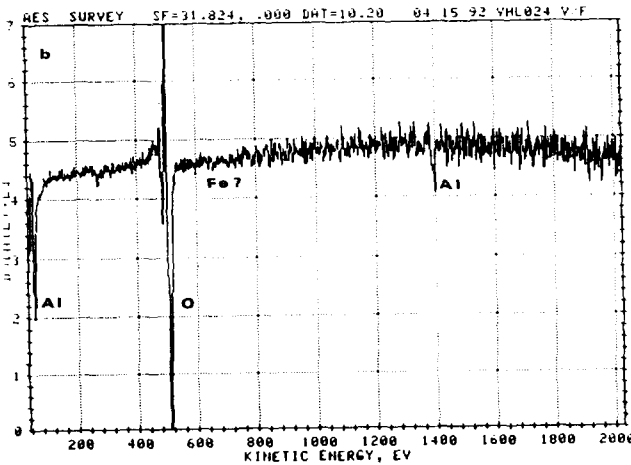
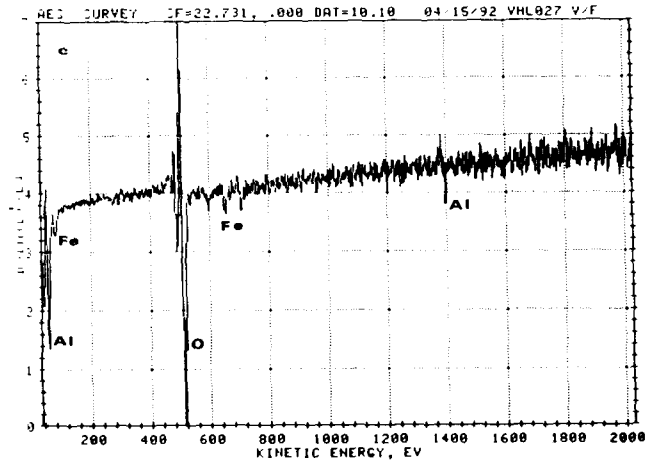
The delaminated alumina coating was investigated by scanning Auger microscopy. Spectra at different parts of the surface are shown in Fig. 8. Three positions were analysed: (a) the surface of the alumina film at the gas side, (b) the surface of the alumina film near the film-substrate interface and (c) the surface of the substrate after delamination of the alumina scale. At position (a) only aluminium and oxygen are detected, at position (b) aluminium, oxygen and perhaps a very small amount of iron are detected, at position (c) aluminium, oxygen and iron are detected. Figure 9 shows an SEM image of delaminated alumina: it is clear that no substrate cracking (decohesion along the interface) occurred, because if it had, depressed regions would be found where the metallic substrate had been removed with the film. From these observations it is clear that delamination of the alumina films takes place by interfacial cracking.

Fig. 8. AES survey spectra for different positions of a delaminated Al₂O₃ film.

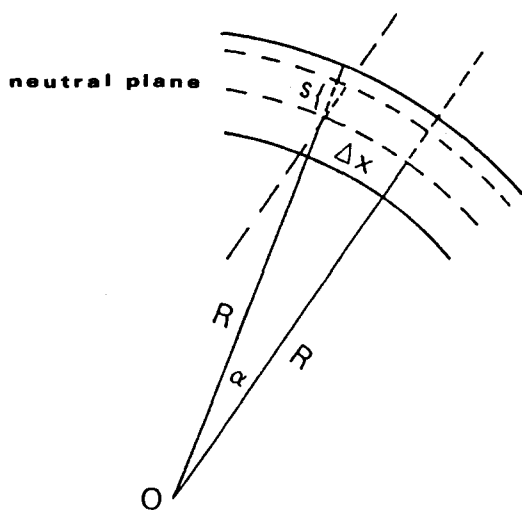
where E_f is the Young's modulus of the film, R is the curvature of the detached film and s is the distance from the neutral plane (see Fig. 10).

Fig. 10. Schematic view of a cross-section of a detached and curled oxide film.

The curvature of the spalled films indicates a stress gradient. With regard to the detached and curled film, the intrinsic stress (no adhesion between the film and the substrate means no thermal stress) at distance s from the neutral plane can be estimated from

$$\sigma_{\text{intrinsic}} = E_f s/R \quad (2)$$
