Rapid Inventory of Earthquake Damage (RIED)

The 25 January 1999 Quindío earthquake in Colombia was a major disaster for the coffee-growing region in Colombia. Most of the damage occurred in the city of Armenia and surrounding villages. Damage due to earthquakes is strongly related to topographic and subsurface geotechnical conditions underneath structures and houses. The RIED project used aerial photographs to obtain a rapid inventory of the earthquake damage right after the seismic event. This inventory was subsequently used to identify any existing relation with subsurface- and topographic conditions.

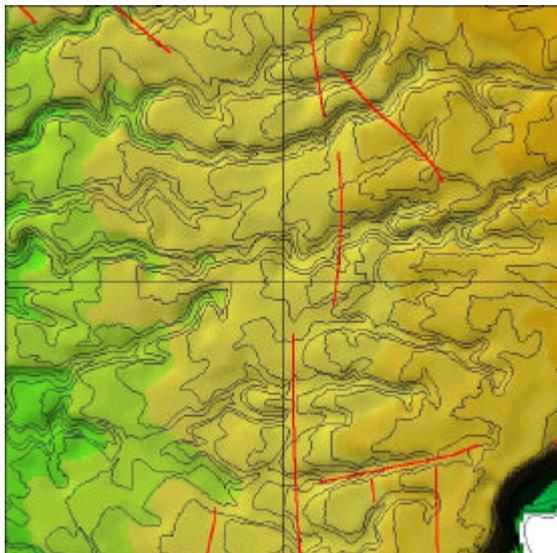
Figure 4. Topographic relief

The presence of topographic undulations (Figure 4) has a marked influence on the surface accelerations of an earthquake. Near steep slopes an amplification of the effects of an earthquake can be expected. Also resonance effects are possible if the dimensions of ridges in the topography coincide with the frequencies of the major tremor of the earthquake. The locations where this resonance effect may take place has been modeled in the GIS and an example of this analysis is given in Figure 5. Both topographic effects can be correlated to the damage patterns of the city of Armenia.

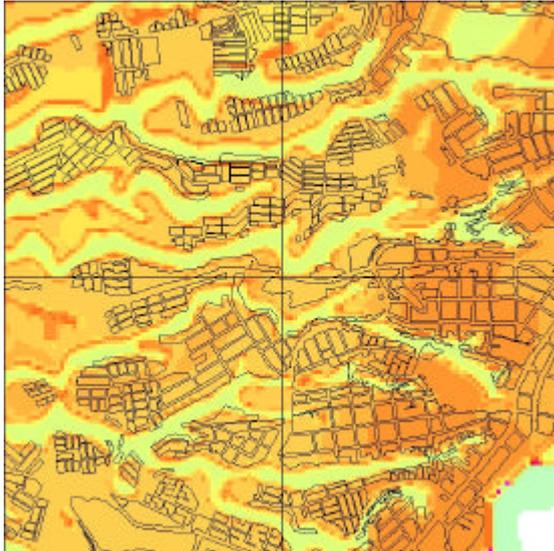
Figure 6. *Seismic acceleration response distribution for 1-2 story buildings*

model was constructed in the GIS which was subsequently used as input for the seismic response model. On the basis of the results of this seismic response analysis different seismic microzonation maps have been made which delineates the difference in seismic responses throughout the area as a function of the subsurface geology. Examples of these microzonation maps are given in Figures 6 and 7.

Additional measures should be taken to reinforce the constructions in those areas, or to avoid building structures in such areas. The aerial photographs also show that three-dimensional site effects occur on some of the ridges in the topography. As there is very little known of these effects a research study has been initiated to study in more detail the three-dimensional aspects of topographic effects on seismic response.
