Modal strain energy-based structural health monitoring validation on rib stiffened composite panels

Keywords: structural health monitoring; composite damage; modal strain energy damage index; automated fibre placement; composite aircraft structure

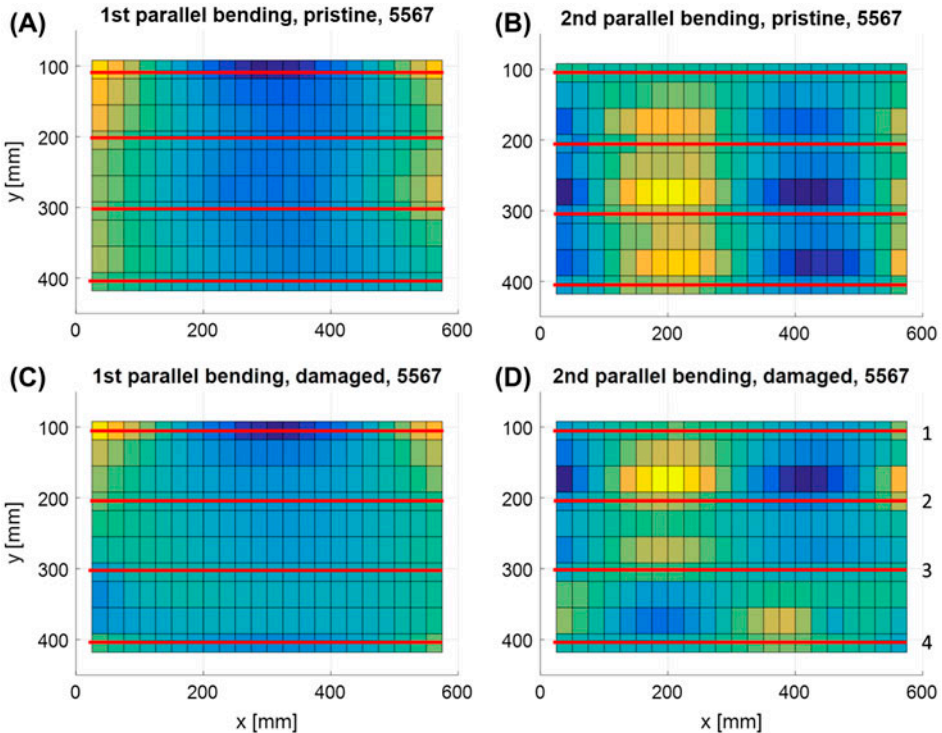
Figure 5. ODS of the plate 5567, relevant for the parallel bending moment mode shapes. (A) and (C) represent 1st bending moment before and after the impact damage, respectively, (B) and (D) represent second bending moment before and after the impact.

Figures 5 and 6 present the ODS of the panel 5567 indicating the first two parallel bending modes and the calculated MSE-DI for both panels 5565 and 5567, respectively. Notice that some natural frequencies could not be determined properly. Furthermore, the natural frequency of first parallel bending mode seems to have gone up after the damage. This mode may have been influenced by different boundary condition caused by the different tension in the elastic chord suspension.

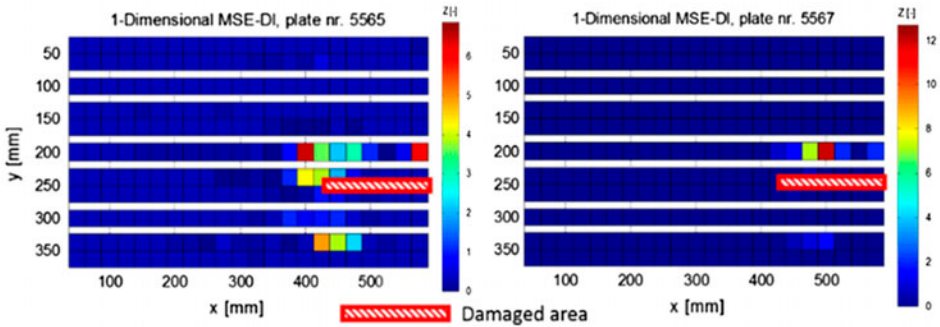
Figure 6. MSE-DI extracted from panel 5565 and 5567.

Figure 6 shows that damage has been detected successfully on both panels, although the peaks appear at different locations, indicating inaccurate damage localization. The highest normalized damage index is found adjacent to the damaged area between stiffeners 2 and 3. However, a number of additional peaks in the MSE-DI appeared in panel 5565, despite the impact being applied at the same location. The modal strain energy is based on the second-order spatial derivative of the mode shapes and therefore is even more inaccurate. The limited number of measured ODS has contributed even more to the inaccuracy.
