# Sustainability of Individual EndoAnchor Implants in Therapeutic Use to Treat Type Ia Endoleak After Endovascular Aneurysm Repair

Kim van Noort, MSc<sup>1,2</sup>

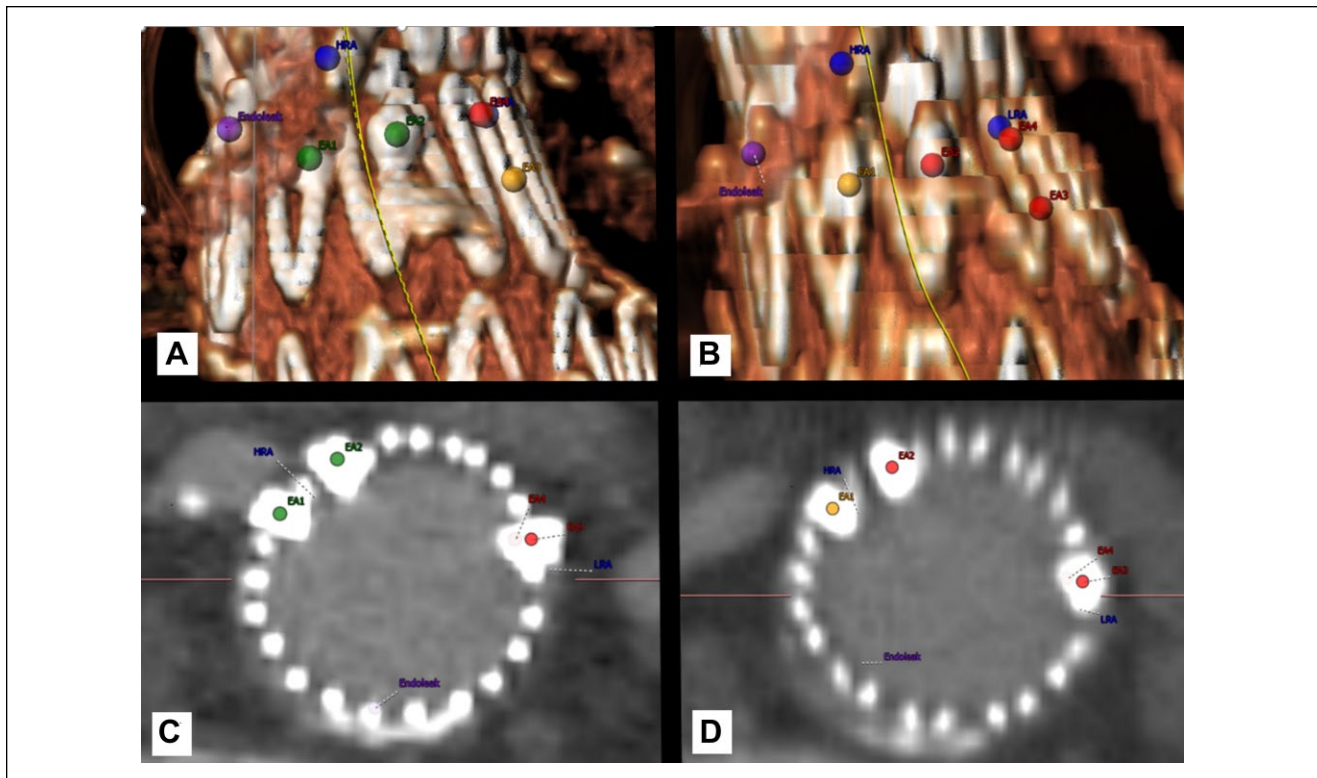
**Figure 2.** (A, B) Three-dimensional and (C, D) axial views of the distribution of EndoAnchor implants at the (A, C) 30-day and the (B, D) 11-month computed tomography angiography scans. Good, borderline, and nonpenetrating EndoAnchor implants are visualized as green, orange, and red dots, respectively. EA1 and EA2 became borderline and nonpenetrating, respectively, at the 11-month follow-up. Note that only 4 EndoAnchors had been implanted, unevenly divided around the aortic neck. The purple dot represents the location of the endoleak and the blue dots represent the locations of the highest and lowest renal arteries (HRA and LRA, respectively).

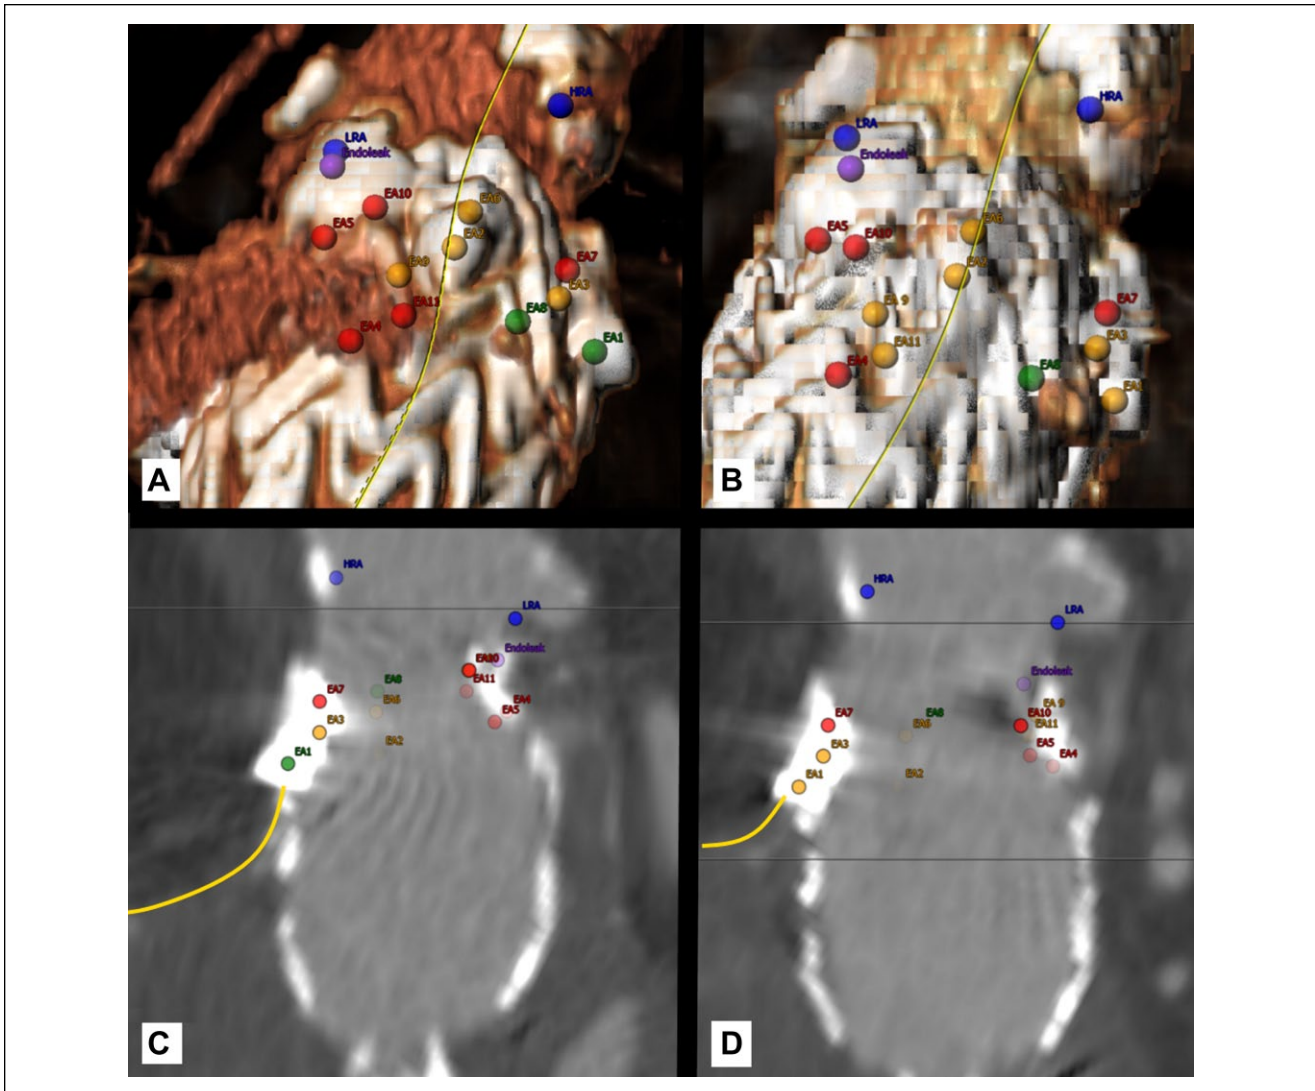
**Figure 3.** (A, B) Three-dimensional and (C, D) longitudinal views of the distribution of EndoAnchor implants at the (A, C) 30-day and the (B, D) 34-month computed tomography angiography scans. Good, borderline, and nonpenetrating EndoAnchor implants are visualized as green, orange, and red dots, respectively. The orange line accentuates the location of the aneurysm sac. The location of the endoleak is visualized with a purple dot. The blue dots represent the locations of the highest and lowest renal arteries (HRA and LRA, respectively). Note that only 2 EndoAnchors had good penetration during initial implant. The majority of EndoAnchors were applied beyond the recommended use.

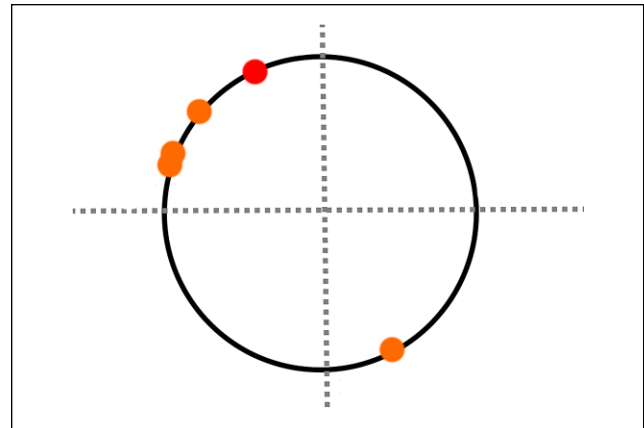
**Figure 4.** The distribution of 5 EndoAnchors that became borderline or nonpenetrating (orange and red dots, respectively) is shown on the axial view of the aortic circumference from the center lumen line reconstruction.

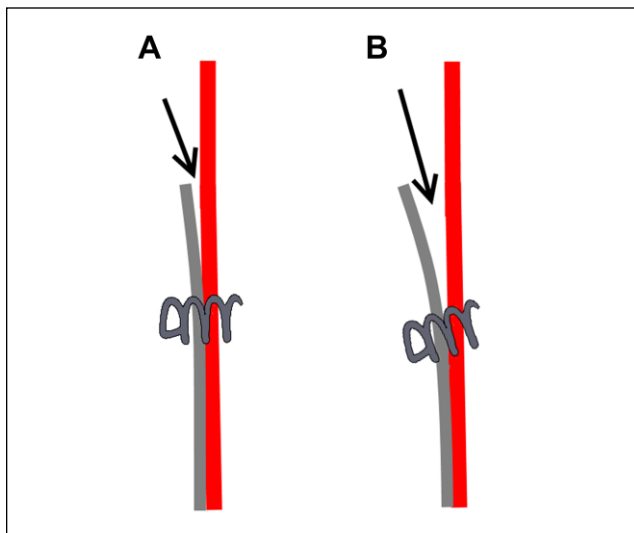
**Figure 6.** Longitudinal schematic representation of (A) an EndoAnchor penetrating the aortic wall (red line); however, there is a space between the aortic wall and the endograft (gray line) proximal to the EndoAnchor implant. (B) Over time, the gap at the proximal edge of the endograft increases due to the pressurization of the gap, which may cause the EndoAnchor to become borderline or even nonpenetrating.
